Eastern Railway

No. ELS/6/Mail/Exp

Sub: Counselling to avoid rail burnt due to wheel slipping.

In connection with the incident of the train no. BOXN(LD)/TWS/SER, T/LD-59BOXN(LD)+1BV, Tonage-5157(T), hauled by Loco no. 28152/WAG-7/SRE., rail burnt occurred over 52m length of rail in 10 places due to wheel slip, enroute Ex-DK, while BOXN(LD) was negotiating up goods (reversible) line in NACC station limit over bridge no B-9 on 01.11.2020. After analysing the incident, the conclusion of the incident as under.

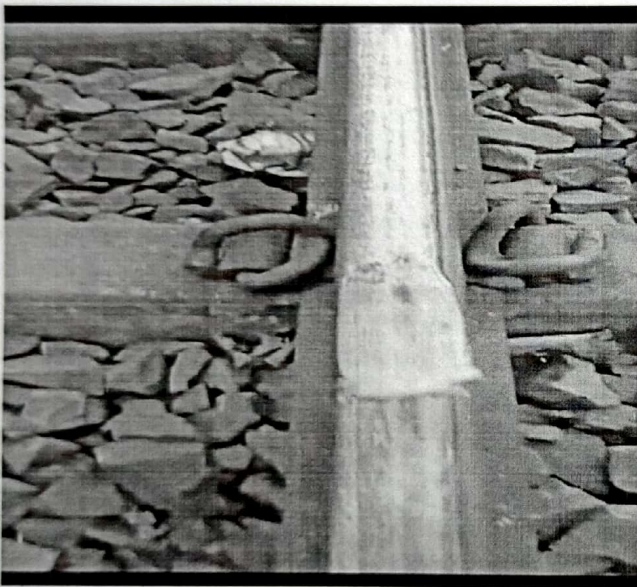
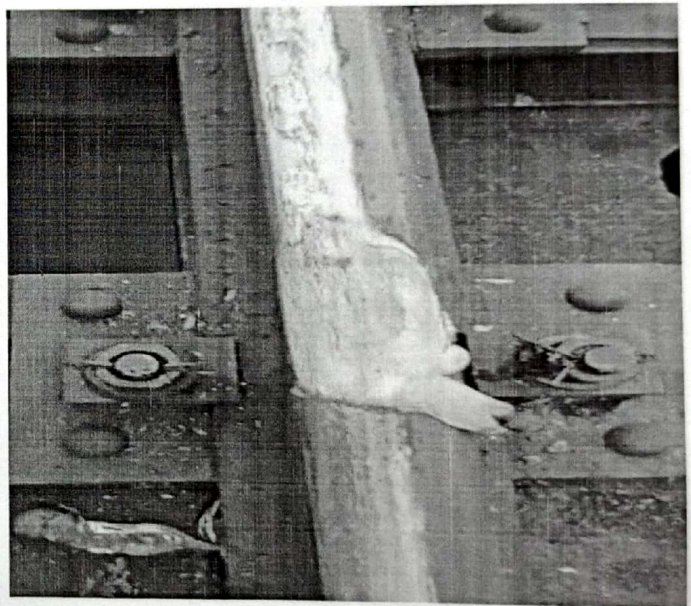
RAIL BURN PICTURE

S.N.	Item	Report
1	Train No. /Loco No.	BOXN (LD)/TWS/SER, Loco no – 28152/WAG-7/SER
2	Line Report	As reported by LPG while the train passed MJT Adv/Str passed on 'Y' aspect, he observed that the next signal NACC Str was not visible from adequate distance due to obstructed by tree branches, resulted he controlled the train. When the signal aspect was visible, he resume traction and at that time wheel slipping took place. To avoid stalling LPG puts Q 51 in wedge condition though sand was not available in the sand box. Finally, rail burnt took place due to heavy wheel slipping.
3	Actual cause of detention	A joint note has been prepared by CLI/OP/SDAH & SSE/PWI/BGA and their observations – They found rail burnt in 10 places in between km no. 9/8X – 9/10X over B-9 bridge in NACC Stn limit. Dragging marks found about 150 mm x 50 mm x 2-3 mm. This occurred due to stalling of loco.
4	Action should be taken by LPM/LPG/LPS/ALP	LPG should follow action while taking charge of the locomotive- i) If no sand is available, should be relayed to TLC at the time of CTO. Depending upon the situation, train should be worked only when sand is made available. ii) Gross weight should be relayed to TLC. If gross weight is high and there is doubt of stalling, banking loco should immediately be demanded through TLC. iii) If wheel slipping/stalling tendency is felt, forcible traction by wedging Q51 must not be done at any cost. Step i&ii must be followed.

- Every LP should be fully conversant with the maximum permissible speeds, gradients & land mark, location of the signals on the section.
- When attacking an up-gradient, the LP will attain sufficient speed at the foot of the gradient & ensuring the maximum permissible speed for that section is not exceeded.

- 'ZQWC' or 'BPQWC' to be pressed during starting (for Conventional locomotive).
- For oily or wet rail 'PSA' to be used for manual sanding.
- In case of brake binding, train to be checked and rectify the same.

- Check availability of dry sand in sand boxes and ensure sanding equipment are in working condition during CTO.
- Do not continue notching forward forcibly while heavy wheel slipping was continuing, where relay Q51 wedged condition (possibility of rail burn).
