Dismantling of Bridge No 1 over Sealdah Yard

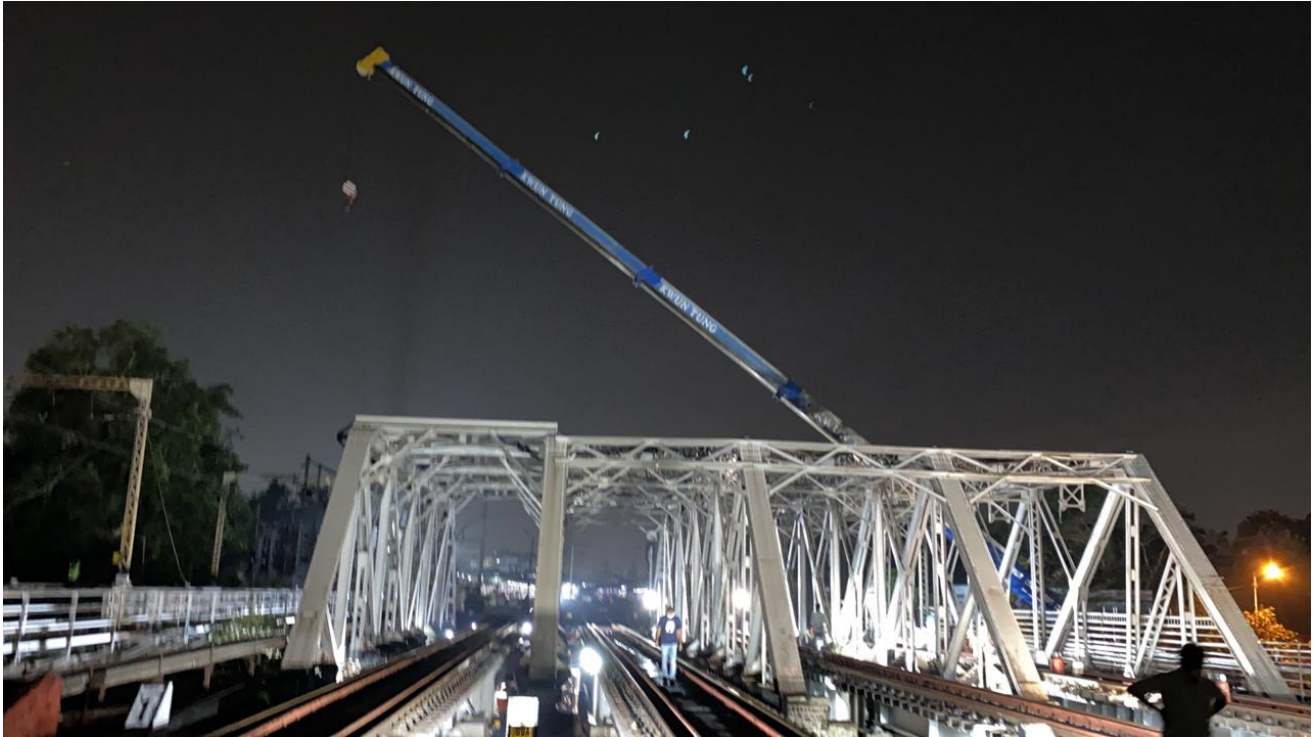
PLACING OF ROAD CRANE NEAR BR 1 FOR DISMANTLING.

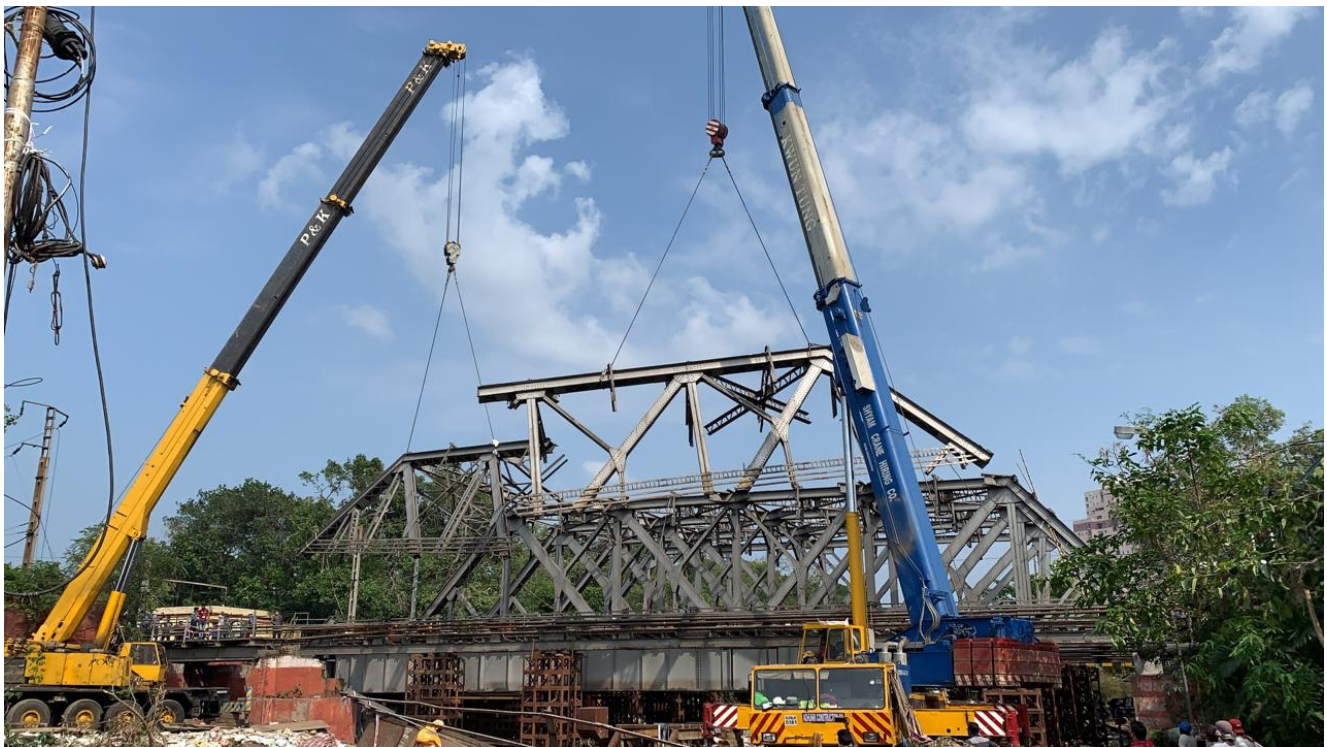
DISMANTLING OF FIRST TRUSS BY 2 NO.S 150 T ROAD CRANE

2 Nos. 150 Ton crane were deployed. 2 Nos. 150 T Road crane were on stand by. 2 No. 140 T Railway crane were on standby. The bridge comprised of 5 No. trusses connected through TLB. The bridge weighed approximately 250 T. There were 14 No. utilities on south of the bridge and 4 No. on north end of bridge including pathway . The utilities were supported on bottom chord of the first and last truss through bracket connections .

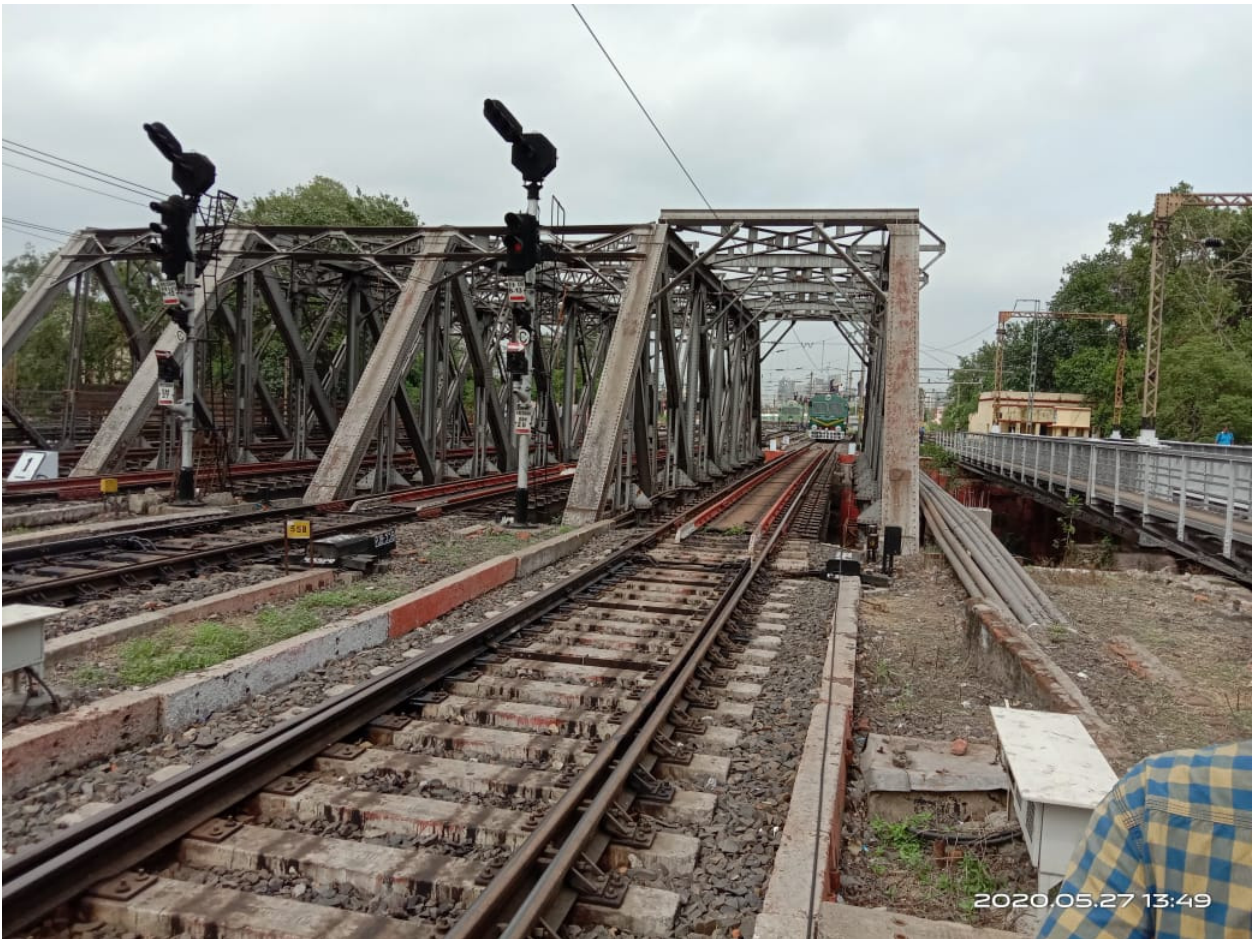
BRIDGE 1 PRIOR TO DISMANTLING

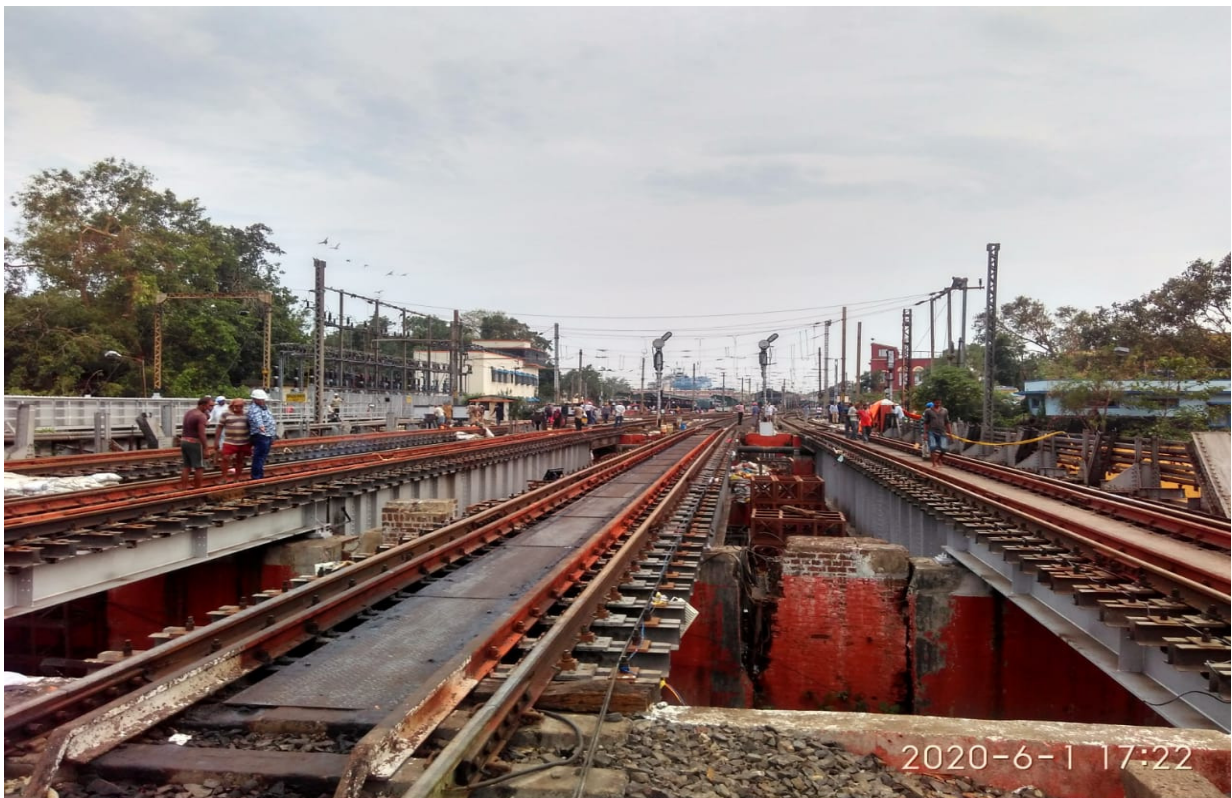
BRIDGE 1 AFTER DISMANTLING OF OLD REDUNDANT TRUSS
