Dismantling of Bridge No 1 over Sealdah Yard

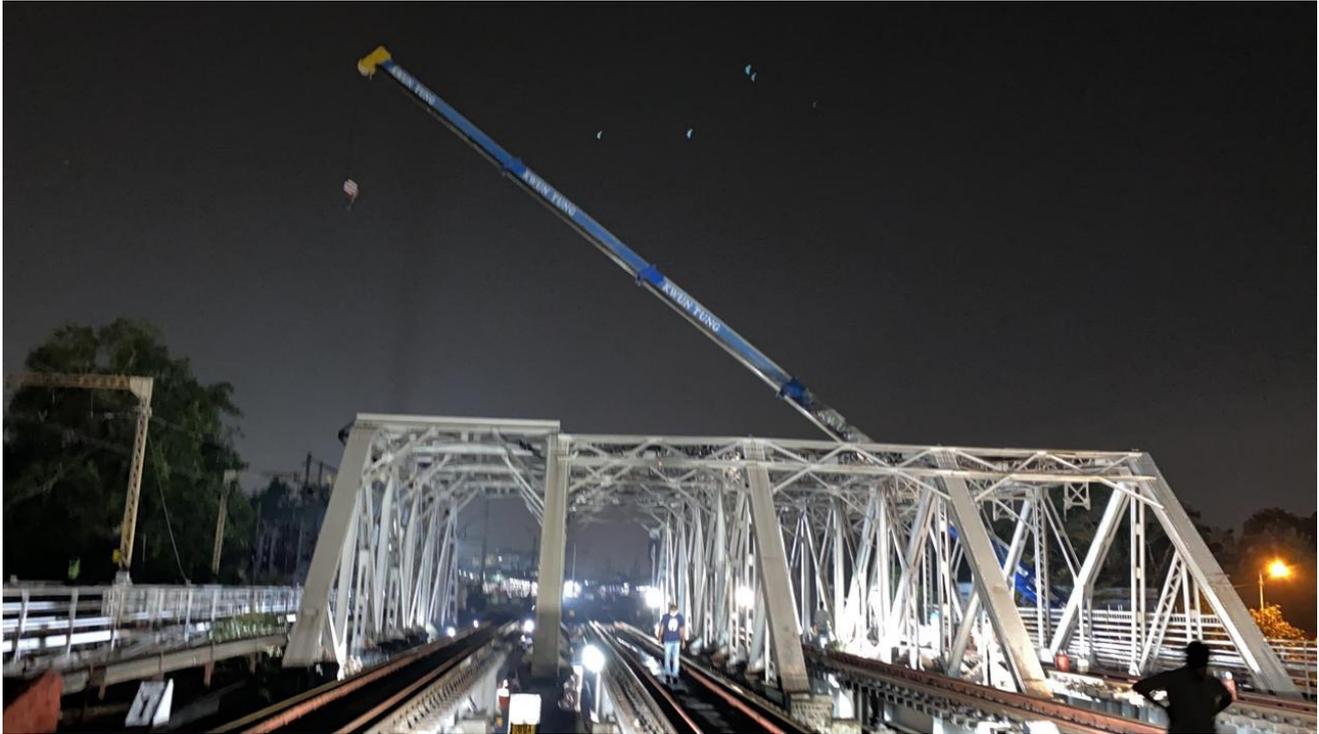
PLACING OF ROAD CRANE NEAR BR 1 FOR DISMANTLING.

- iii) On the southern end of the bridge, there is another bridge semi through type girder which has one track (line no.5) over it.
- iv) Above site constraints implied that Road cranes could be deployed on one side of the bridge only. This was also required because one line had to kept at least diesel fit as remaining 4 lines were to be blocked. Another constraint was narrow road width of 3 m on either side of the canal where crane had to be placed and propping had to be done but consolidated ground was not available .

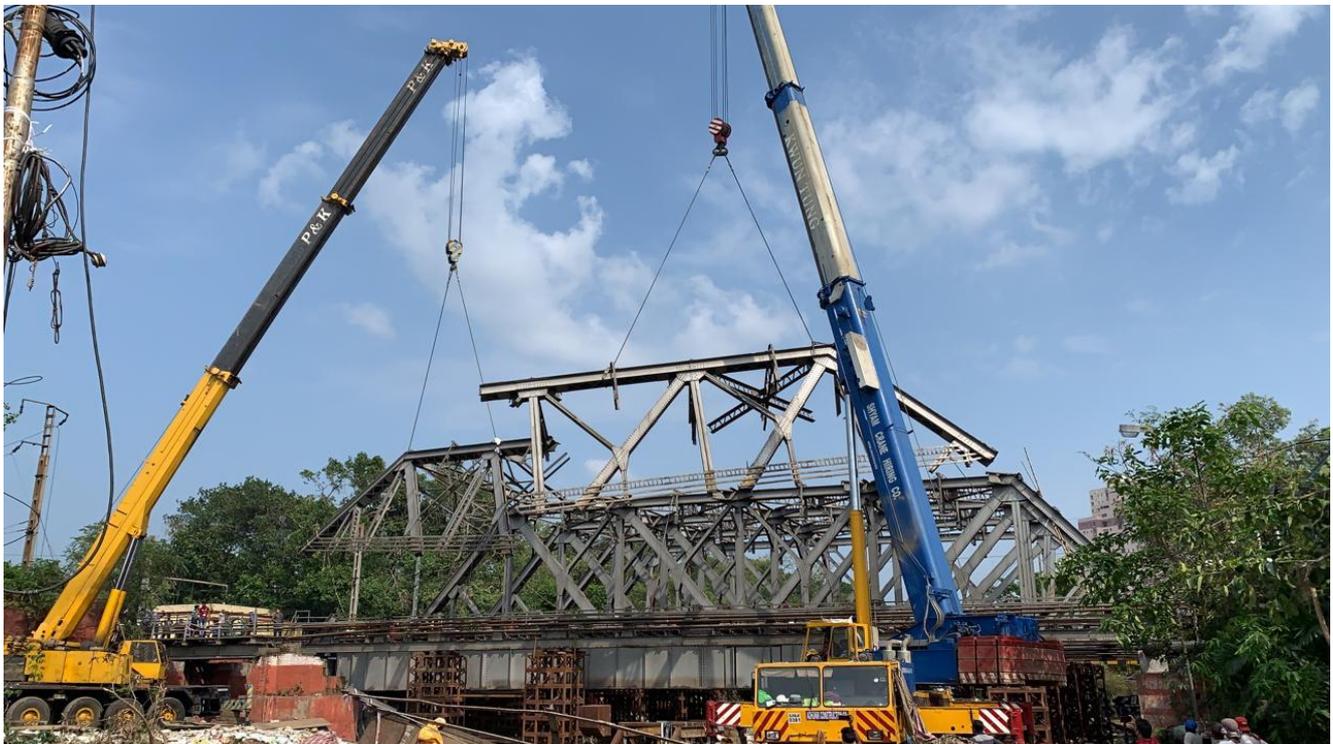
DISMANTLING OF FIRST TRUSS BY 2 NO.S 150 T ROAD CRANE

2 Nos. 150 Ton crane were deployed. 2 Nos. 150 T Road crane were on stand by. 2 No. 140 T Railway crane were on standby. The bridge comprised of 5 No. trusses connected through TLB. The bridge weighed approximately 250 T. There were 14 No. utilities on south of the bridge and 4 No. on north end of bridge including pathway . The utilities were supported on bottom chord of the first and last truss through bracket connections .

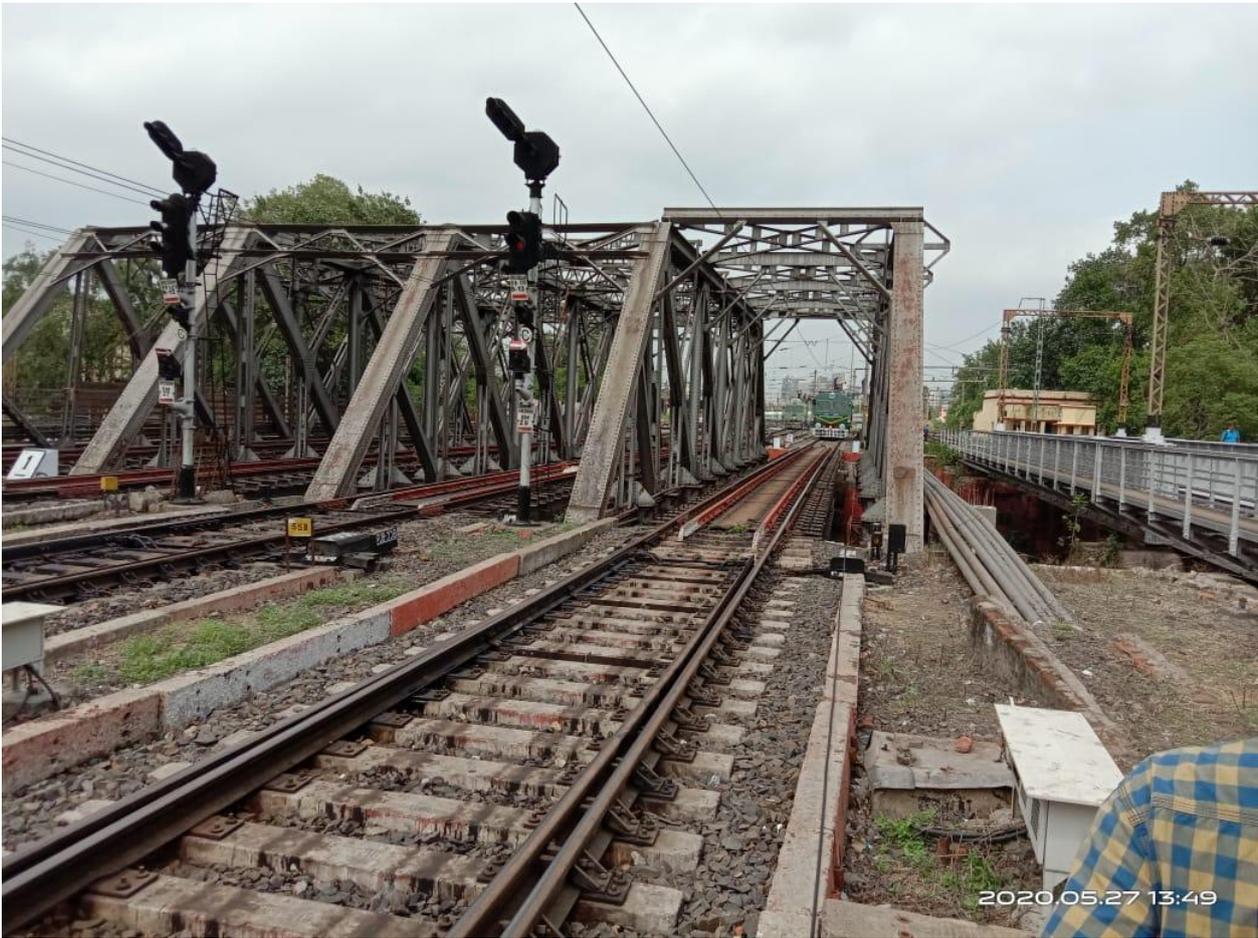
BRIDGE 1 PRIOR TO DISMANTLING

Bridge No. 1 was an open web girder type bridge in Sealdah yard of 33.55 m span and had four railway tracks over it. The bridge was constructed in 1862 and was an early steel girder bridge. The work of regirdering of this bridge was sanctioned in 2005-06. The regirdering work was completed in 2007-08 by construction department. The new plate girders were inserted by cutting the cross girder of the existing open web girder bridge. The remaining structure however could not be dismantled till date due to various reasons.

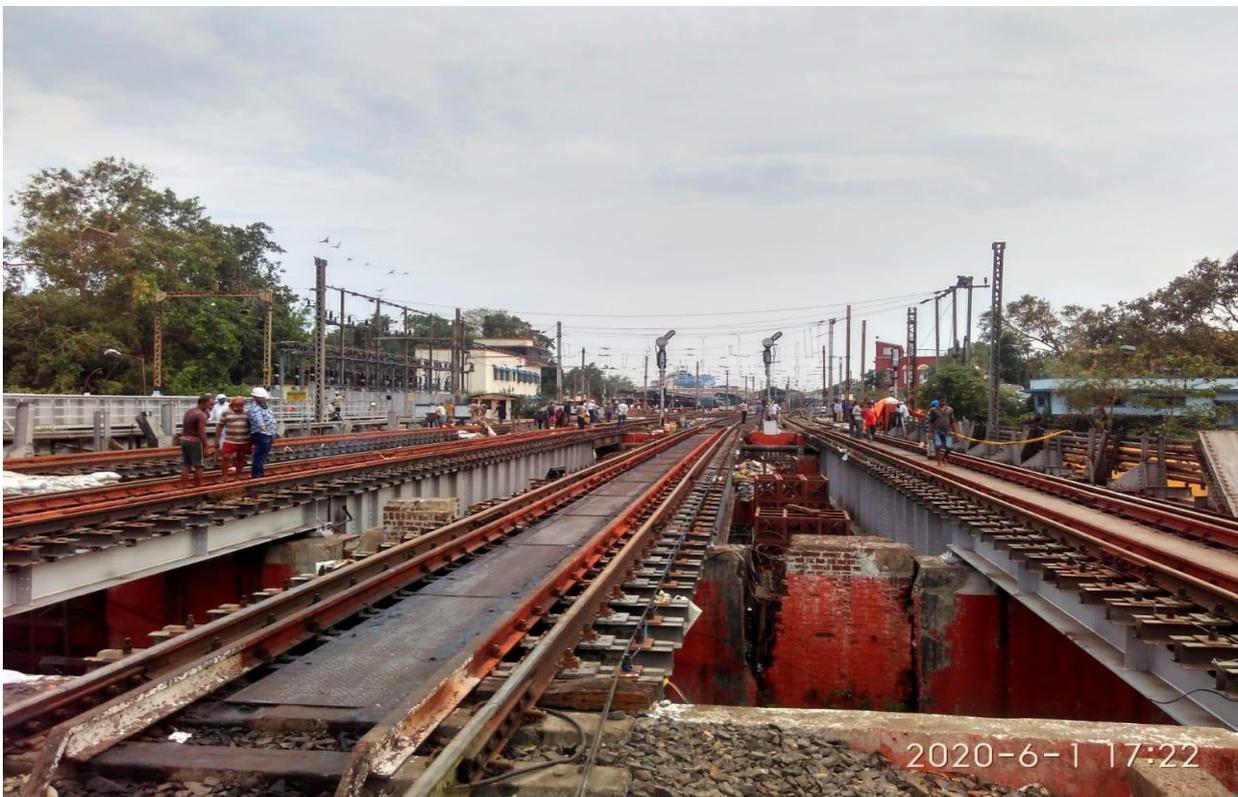
BRIDGE 1 AFTER DISMANTLING OF OLD REDUNDANT TRUSS
